# Partial Discharge Detection using Rogowski Coil Sensor on Medium Voltage Aerial Bundle Cable

**Abstract**— It is well known that the internal partial discharge (PD) are small electric sparks that occurred due to defect in power cable insulation. This will lead to premature failure of cable which consequently interrupt the supply on the distribution lines. In this paper, the results of internal partial discharge detected by Rogowski coil (RC) sensor were presented. The RC sensors were designed, fabricated and tested in the laboratory with varying high frequency sinusoidal and impulse signals. An artificial PD defect was also created inside a straight through joint (STJ), medium voltage aerial bundle cable (MVABC) to generate PD signals. PD testing data in the laboratory were collected and analysed. Results indicate that the RC sensors are able to detect injected continuous sinusoidal signal at lower frequencies ranging from 0.5 MHz to 10 MHz. The detected PD signal generated from artificial PD defect from RC sensor was found to be slightly higher amplitude as compared to commercial PD sensor, High Frequency Current Transformer (HFCT). Thus findings show that the RC sensor is able

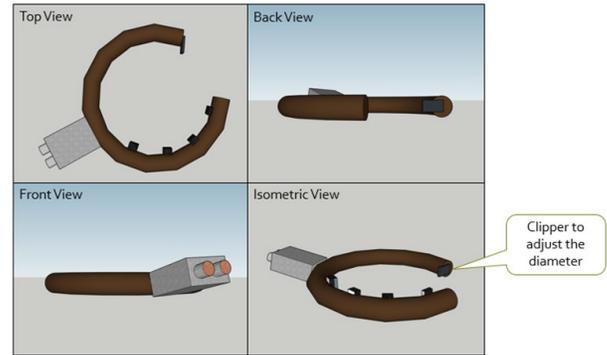
With the use of ten (10) pieces solid ferrite core, the structural design was considered to be flexible RC as shown in Fig.2.

Fig. 2. Flexible RC sensor design

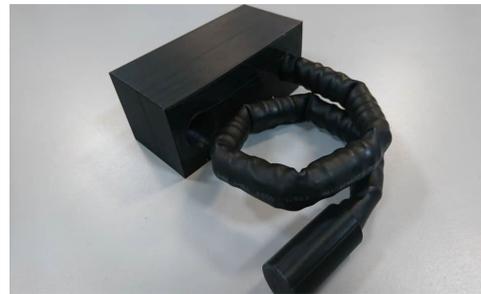
In total, fifteen (15) RC sensors were fabricated. Fig. 3 shows the prototype of RC sensor and casing are made of Acrylonitrile Styrene Acrylate (ASA) using a 3D printer. The prototype RC sensor employed exceptional strength, rigidity and rated as IP65 ingress protection. The core of the coil are protected by two layers of heatsink and wrapped in poly tape with 80°C maximum operating temperature.

Fig. 3. Prototype of RC sensor

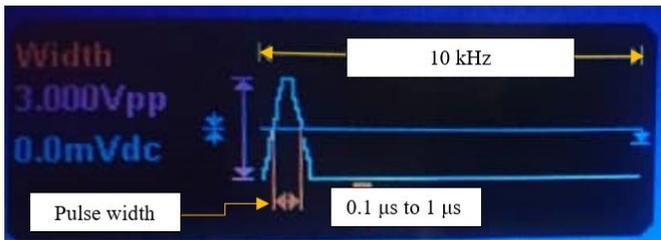
During partial discharge occurrence, a current pulse is produced. In order to simulate a partial discharge, the Waveform Generator is set to generate pulse wave with amplitude of 3 V p-p. The frequency repetitive of the set-up circuit is constant at 10 kHz with pulse width is varied from 0.1 μs (10 MHz) to 1 μs (1MHz) as shown in Fig.4. All detected and measured signal from waveform generator via RC sensors were analysed.

Fig. 4. Input impulse test waveform

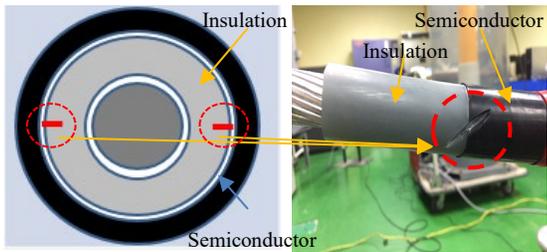
The artificial PD defect as shown in Fig. 5 was created in the MVABC joint of 11 kV 3C X 240 mm<sup>2</sup> + 50 mm<sup>2</sup> MVABC cable. The artificial PD defect was created by damaging the insulation screen cut back of the cable. The insulation screen cut back of the cable were indented to create an air pocket later covered by the insulation layer of the joint.

Fig. 5. Artificial PD defect at MVABC joint

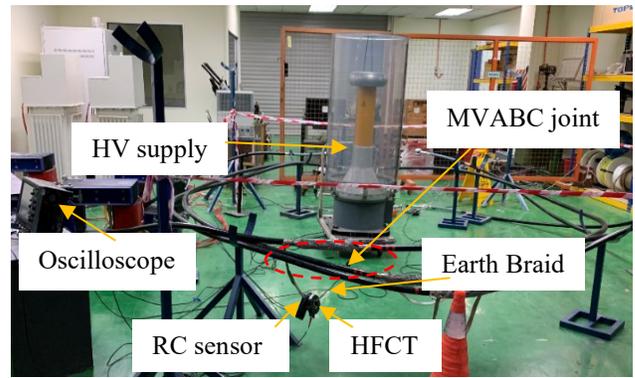
MVABC with PD defect was tested at the laboratory as shown in Fig. 6. Both RC sensor and HFCT were clamped at the earth braid of the cable. The MVABC cable was injected with  $U_0$  test voltage. The PD signal was captured by RC and HFCT, connected to the oscilloscope and analysed.

Fig. 6. Laboratory test set-up for artificial PD defect at MVABC joint

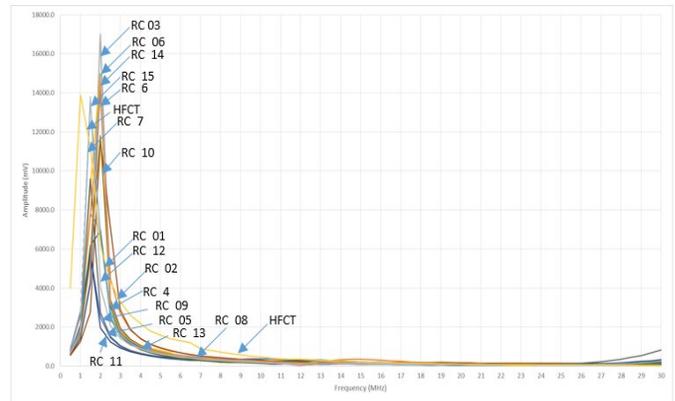
Fig. 7 shows the comparison of voltage amplitude detected by RC sensor and HFCT using continuous sinusoidal test waveform at different high frequencies input signal. The frequency was varied from 0.5 MHz to 30 MHz.

Fig. 7. voltage amplitude detectin by RC and HFCT sensor at various frequency

From figure above, both of the sensors, RC sensors and HFCT successfully detects injected continuous sinusoidal signal amplitude at lower frequencies, 0.5 MHz to 10.0 MHz. It was observed that the amplitude detected decreases as the frequency increase. The result also shows that the RC and HFCT sensor reached highest amplitude at frequency range of 1.5 MHz to 3 MHz which indicate that the RC and HFCT sensors have higher sensitivity at low frequencies of continuous sinusoidal signal.

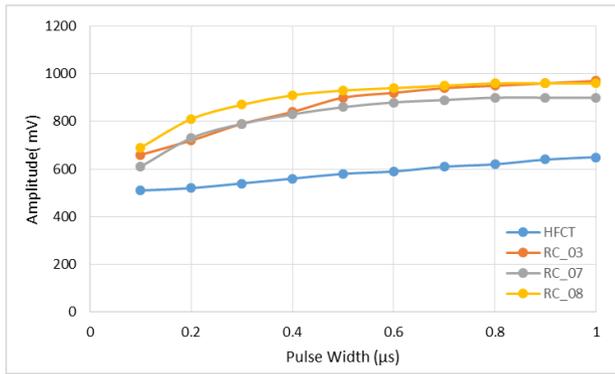
Fig. 8 shows the voltage amplitude in each impulse test duration. The pulse wave width were varied from 0.1 μs (10 MHz) to 1 μs (1MHz) injected to a cable. HFCT and several RC sensors were clamped onto the cable to observe and assess the sensor detectability. The results shows that the voltage

amplitude increase as the pulse duration increase. This indicates that the sensor able to detect signal frequency from 1 MHz to 10 MHz with high gain on the lower frequency range.

Fig. 8- Pulse duration set versus voltage amplitude

For HFCT, the amplitude gain was observed to be more stable as only slightly increases throughout the test frequency range as compared to RC sensor. However amplitude gain for RC sensor at higher frequency range was observed to be higher compared to the HFCT thus exhibited better sensitivity. Table I shows the detected pulse signals waveform of the sensors at 0.1µs (10 MHz) and 1µs (1MHz).

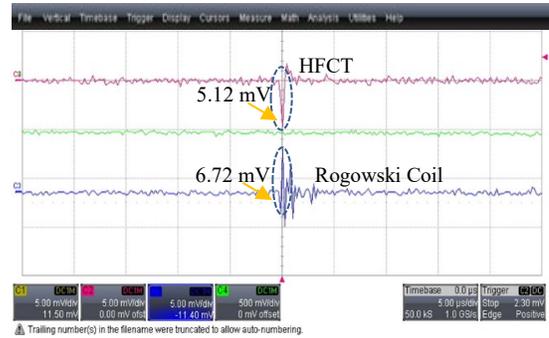
Fig. 9 shows the results of RC sensor detecting the PD signal from artificial PD defect. The oscilloscope was used to display PD signals which indicate that the RC sensors able to detect the artificial PD defect signal as well as the HFCT sensor. PD testing was repeated for five (5) times (D1 to D5). The test results were tabulated in Table II. The average detected PD signal amplitude from artificial PD detected by RC sensor is 5.38 mV and 4.07mV for HFCT sensor. The detected PD signal frequency is 2.5 MHz or 0.4 µs pulse width. This is in line with previous impulse voltage test where at 0.4 µs, RC sensors have higher amplitude gain compared to HFCT sensor.

Fig. 9. Artificial PD defects result detected using RC and HFCT sensor

Data	Oscilloscope Channel (CH)	Max Peak (mV)
D1	CH 2- HFCT sensor	3.84
	CH 3- RC	5.44
D2	CH 2- HFCT sensor	5.12
	CH 3- RC	6.72
D3	CH 2- HFCT sensor	4.03
	CH 3- RC	5.76
D4	CH 2- HFCT sensor	4.16
	CH 3- RC	5.12
D5	CH 2- HFCT sensor	3.20
	CH 3- RC	3.84
Average for 5 data collected	CH 2- HFCT sensor	4.07
	CH 3- RC	5.38
